INDOOR AIR QUALITY ASSESSMENT

**Willett Elementary School
32 Watson Avenue
Attleboro, MA**

Prepared by:
Massachusetts Department of Public Health
Bureau of Environmental Health
Indoor Air Quality Program
May 2017

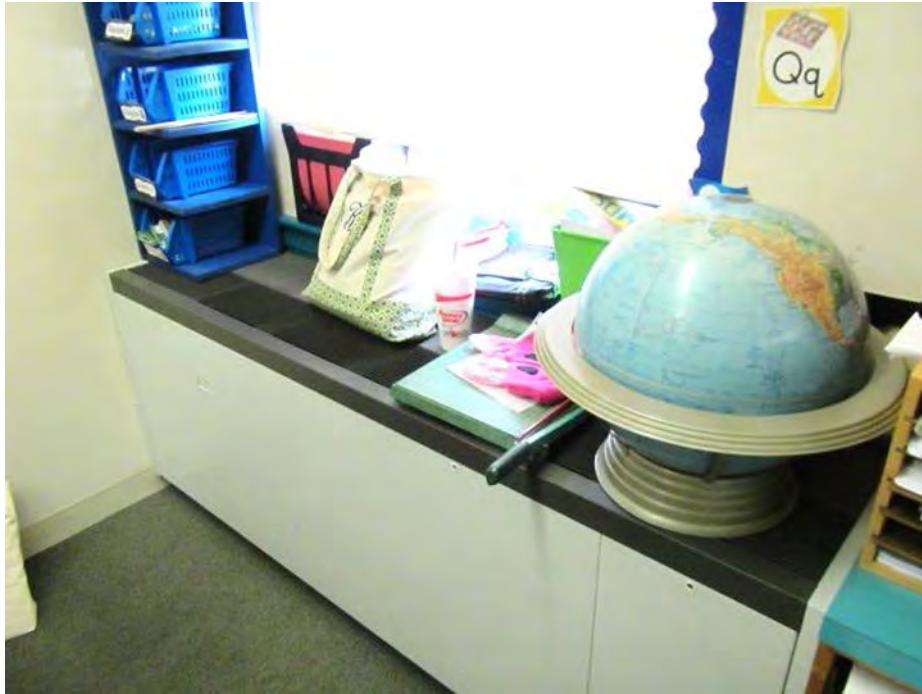
Picture 1

Fresh air is provided by a combination of unit ventilators (univents) located in individual classrooms (Picture 1) and air handling units (AHUs; Picture 2), which serve central areas such as the gym, library and office areas. The unit ventilators draw fresh air through a vent on the exterior wall (Picture 3). Air is mixed with return air from the room, filtered, heated (if needed) and delivered back to the room (Figure 1). Air from the AHUs is filtered, heated or cooled as needed, and delivered to rooms via ducted supply vents. Exhaust vents are located on the ceilings of rooms or in closets (Picture 4) and are ducted to fans on the roof. Additional exhaust vents are located in toilet rooms and other areas which produce pollutants.

While nearly all of the univents were operating at the time of the assessment, some exhaust vents did not appear to be operating, which may indicate they were deactivated or inoperable. In addition, some of the univents were partially blocked by items or furniture (Pictures 1 and 5; Table 1), which will reduce the effectiveness of the equipment. Additionally, in many classrooms, exhaust vents are located near the classroom doors and many of these doors were open, which reduces the effectiveness of the exhaust vent to draw stale air from the classroom.

Classroom unit, note items on top of diffuser

1. Operate all supply and exhaust ventilation equipment continuously during occupied periods.
2. Use openable windows to supplement fresh air during temperate weather. Ensure all windows are tightly closed at the end of the day.
3. Remove items and furniture blocking univents.
4. Check exhaust vents for air draw periodically and repair any non-operating vents.
5. In rooms with exhaust vents near doors, ensure doors are closed during occupancy for optimal operation.

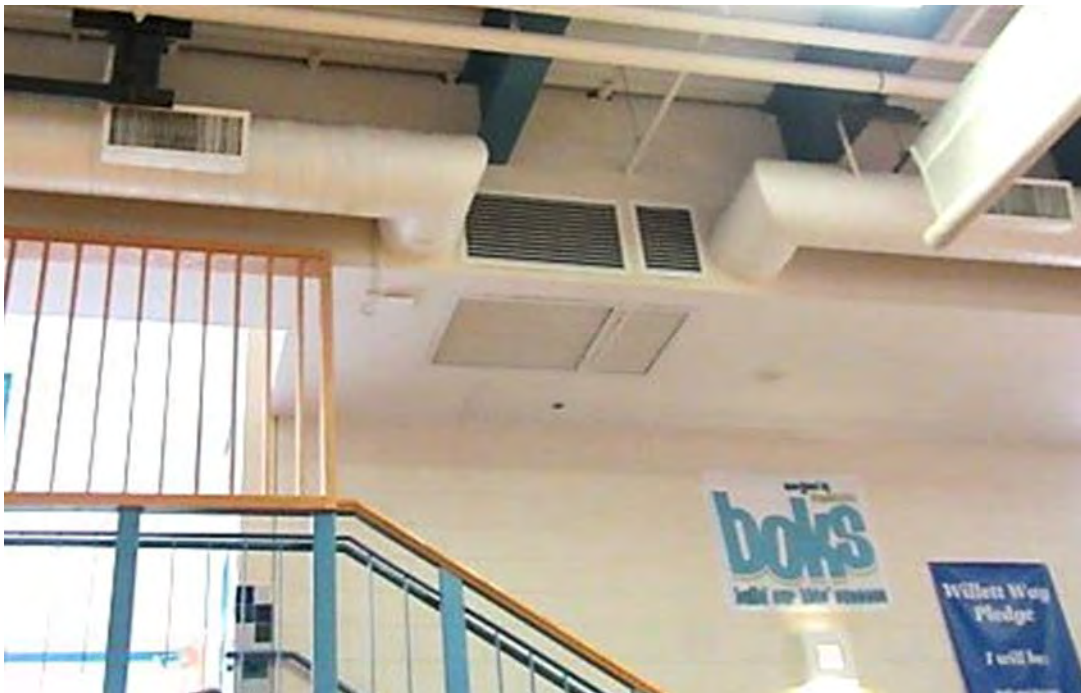
Picture 2

Air handling unit in gym

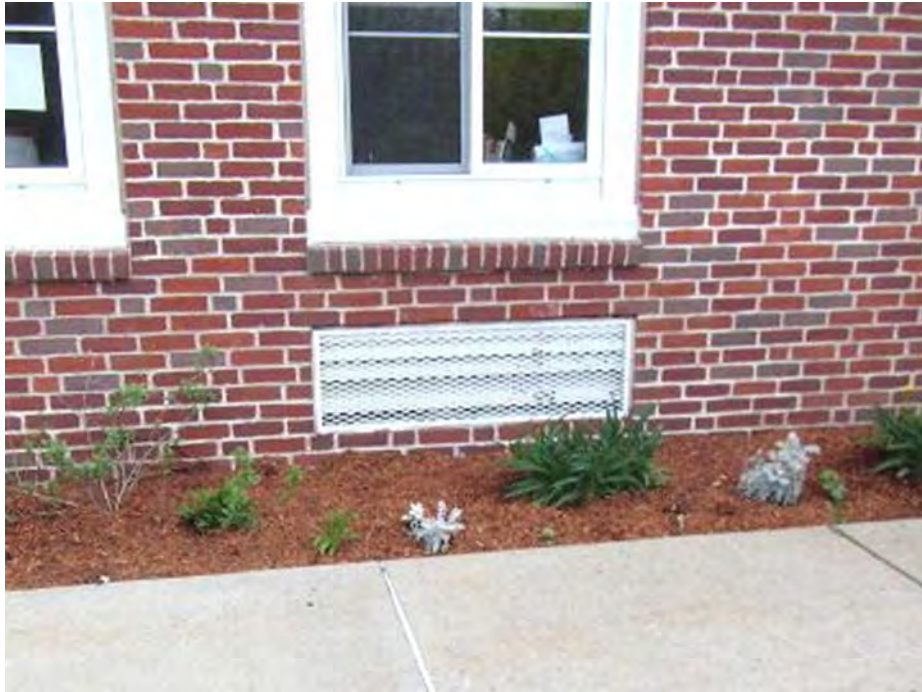
Picture 3

Univent fresh air intake

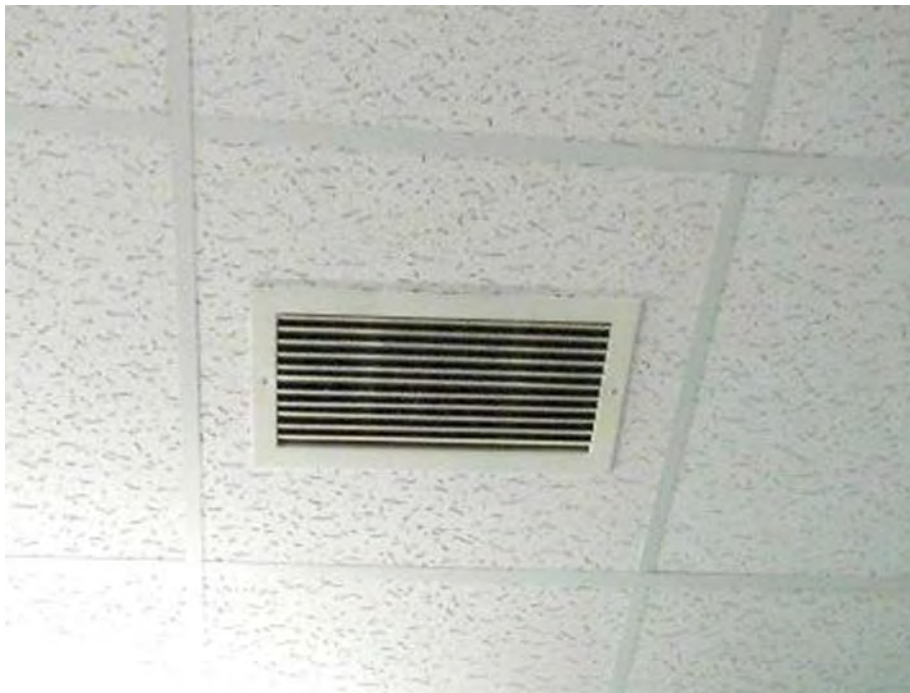
Picture 4

Ceiling-mounted exhaust vent

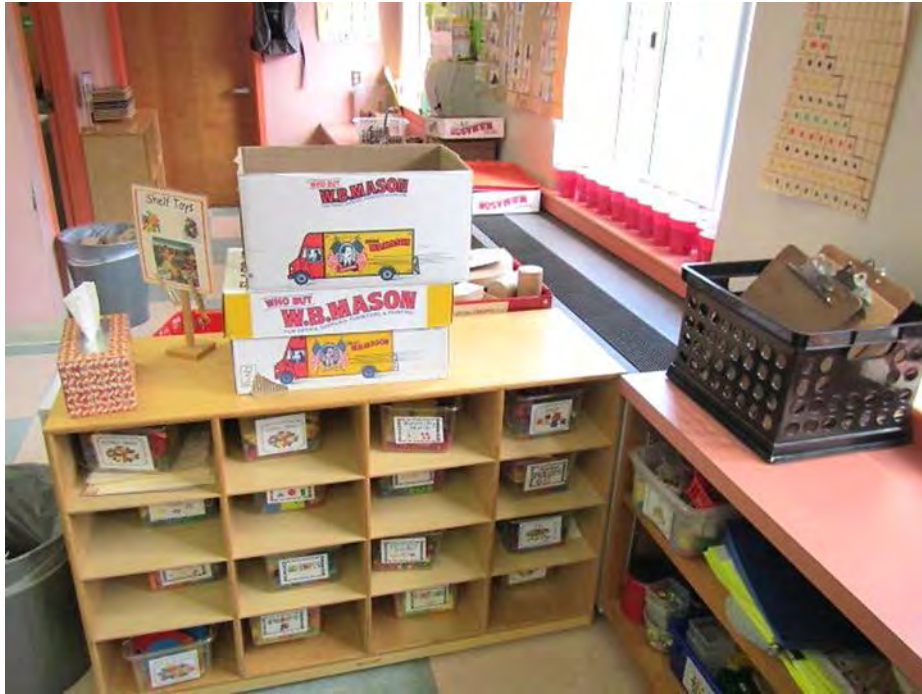
Picture 5

Univent obstructed by classroom furniture

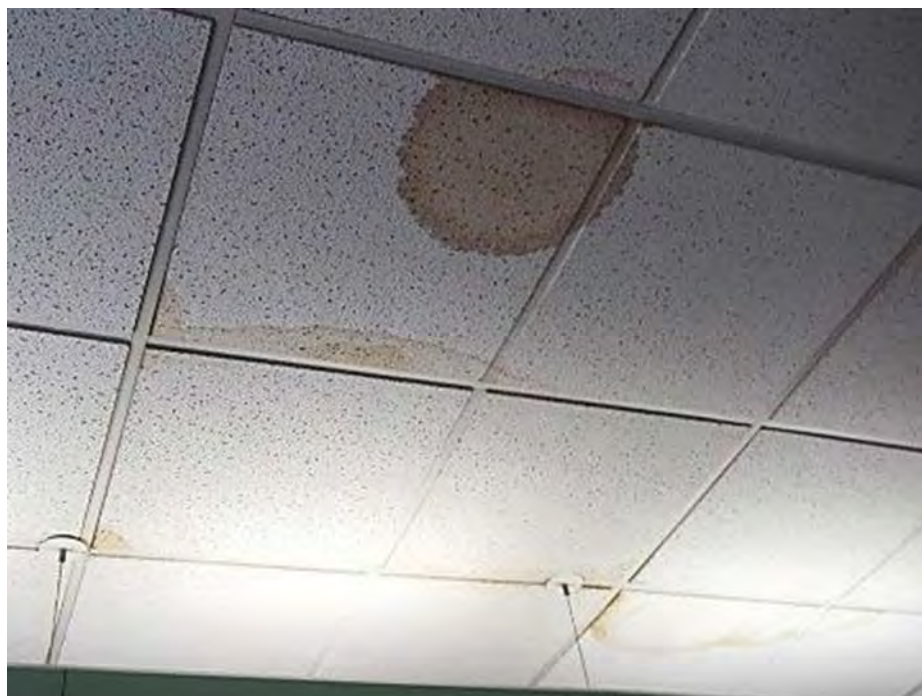
Picture 6

Water-damaged ceiling tiles were observed in some classrooms and hallways (Picture 6; Table 1), which indicate leaks from the building envelope or plumbing system. These tiles should be replaced after the leak is found and repaired.

Water-damaged ceiling tiles

7. Ensure roof and plumbing leaks are repaired and replace water-damaged ceiling tiles.
8. Properly maintain plants, including drip pans, to prevent water damage to porous materials. Plants should also be located away from air diffusers to prevent the aerosolization of dirt, pollen, and mold.

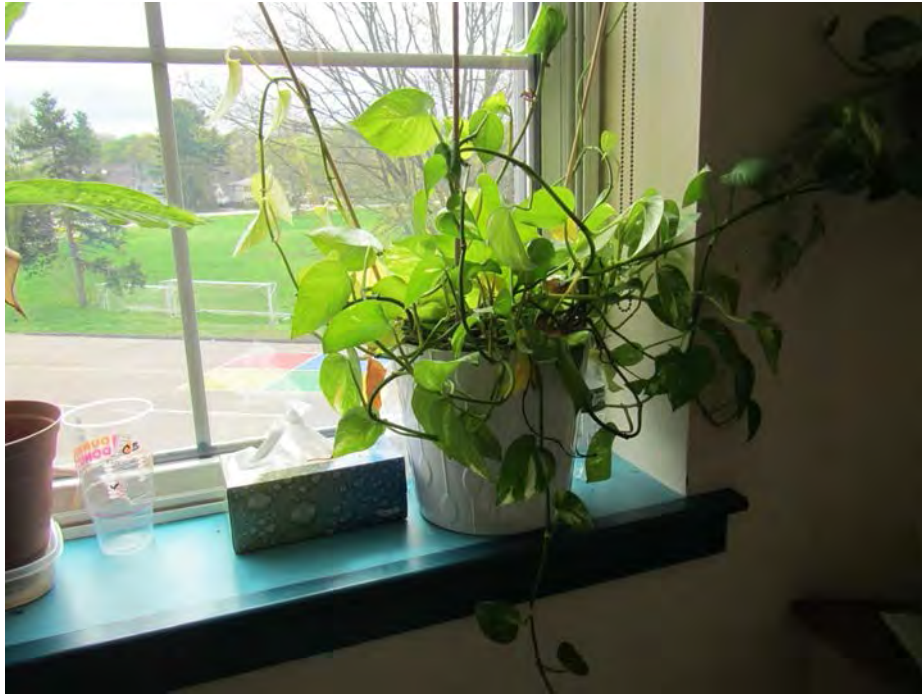
Picture 7

Plants were observed in a few areas (Picture 7; Table 1). Plants can be a source of pollen and mold, which can be respiratory irritants to some individuals. Plants should be properly maintained and equipped with drip pans and should be located away from air diffusers to prevent the aerosolization of dirt, pollen and mold. A few classrooms had terrariums, which should be kept clean to prevent odors.

Plants in classroom

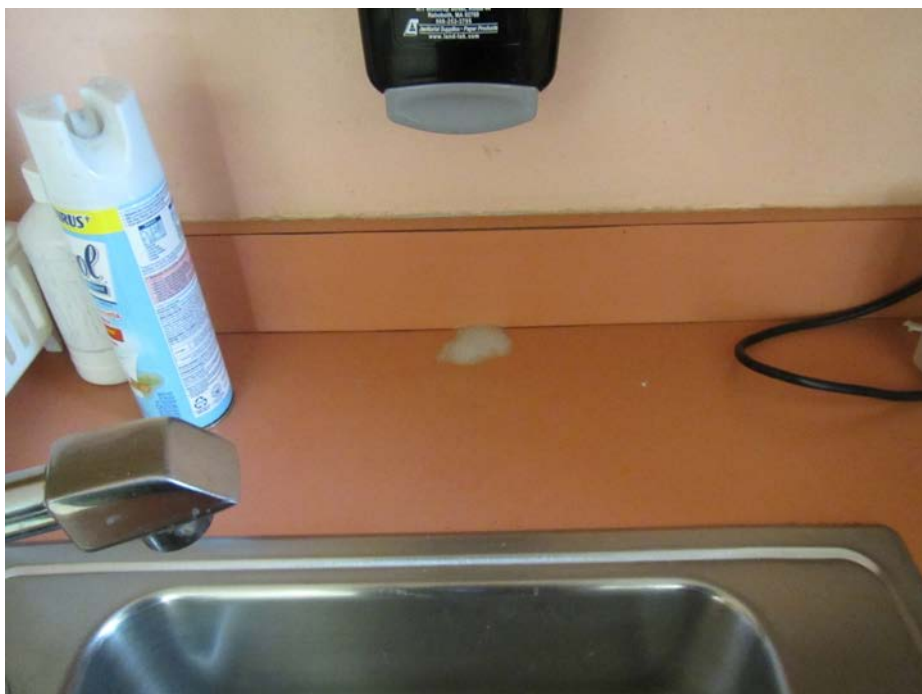
Picture 8

Sinks were observed in a number of classrooms. Some of the sinks examined lacked caulking in the space between the backsplash and countertop (Picture 8; Table 1), which may allow water damage to building materials. Many sinks examined also had porous items (paper, boxes) stored inside the sink cabinet, which is a moist environment.

Unsealed sink backsplash, also note cleaning/sanitizing product

9. Properly maintain terrariums to prevent odors.
10. Repair/caulk open sink backsplashes. Refrain from storing porous items or large amounts of items under sinks.

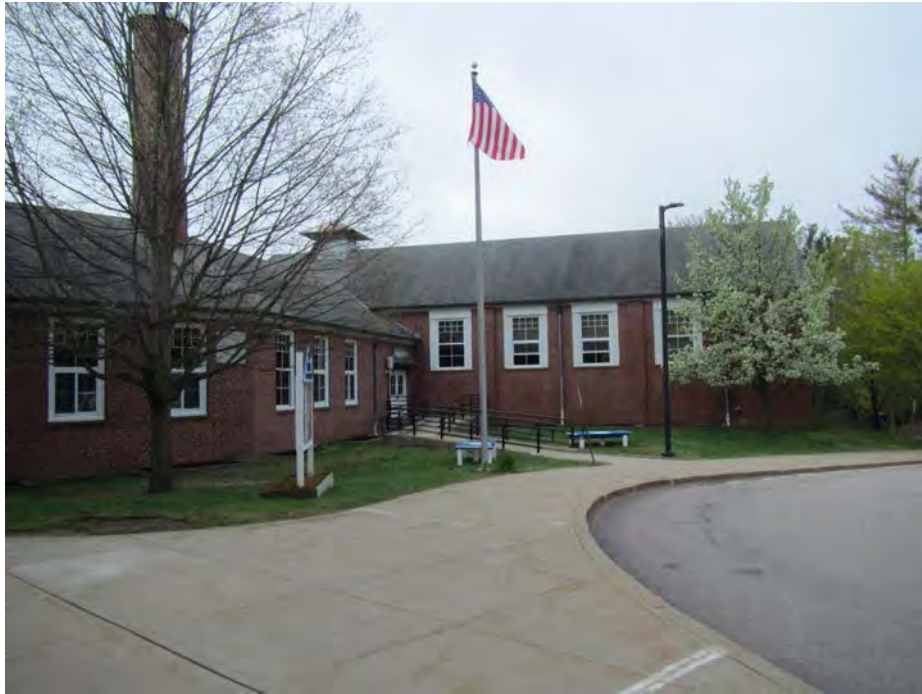
Picture 9

Plants and trees were observed close the exterior of the building envelope (Picture 9). This can lead to deterioration of the building envelope due to root infiltration and dampness against the exterior surface. Plants can also be a source of debris and pollen to air intakes and drains. Plants should be trimmed away from the building and from overhanging the roof.

Trees next to building

11. Trim back trees and plants from next to the building and overhanging the roof.
12. Reduce use of products and equipment that create VOCs and ozone; only use in well-ventilated areas.

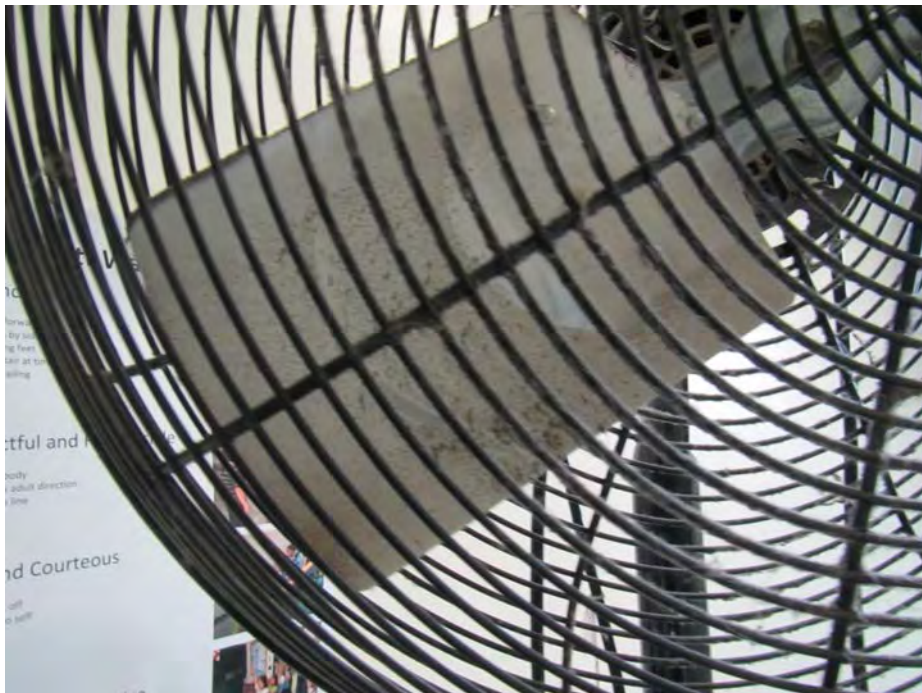
Picture 10

Many classrooms had wall-mounted fans and some had additional personal fans. Some of these had dusty blades (Picture 10; Table 1). Some supply and exhaust vents were also observed to be dusty. This dust can be reaerosolized when the equipment is activated. In some areas, items, including books, papers, toys and decorative items were observed on floors, windowsills, tabletops, counters, bookcases, and desks (Picture 11; Table 1), which can make it more difficult for custodial staff to clean.

Dust on fan blades

15. Regularly clean/vacuum univent cabinets, supply/return vents and fans to avoid aerosolizing accumulated particulate matter.
16. Clean window-mounted air conditioner filters prior to the start of the cooling season and according to the manufacturer's instructions.

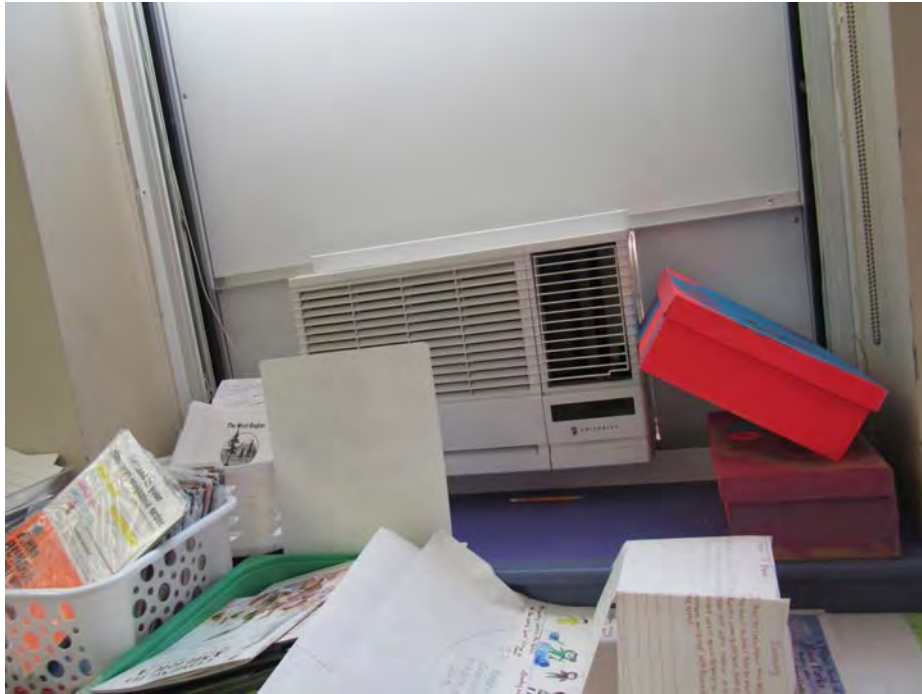
Picture 11

Paper and other items on counter

19. Consider reducing the amount of items stored in classrooms to make cleaning easier. Periodically move items to clean flat surfaces.
20. Continue to adopt the US EPA (2000) document, "Tools for Schools", as an instrument for maintaining a good IAQ environment in the building available at:
<http://www.epa.gov/iaq/schools/index.html>.
